**TECHNICAL TRANSACTIONS**  
CIVIL ENGINEERING**CZASOPISMO TECHNICZNE**  
BUDOWNICTWO

3-B/2014

KATARZYNA NOWAK\*, KATARZYNA NOWAK-DZIESZKO\*

## IMPACT OF PREPARATION PROCEDURES ON RESULTS OF AIRTIGHTNESS TESTS

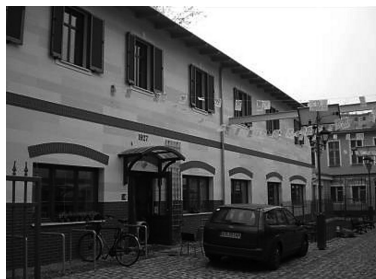
Fig 1a. Building A

1. Building A (Fig. 1a) – two storey office building, building volume 1074 m<sup>3</sup>, usage area 377,5 m<sup>2</sup>.
2. Building B (Fig. 1b) – two storey office building, building volume 305,5 m<sup>3</sup>, usage area 108 m<sup>2</sup>.

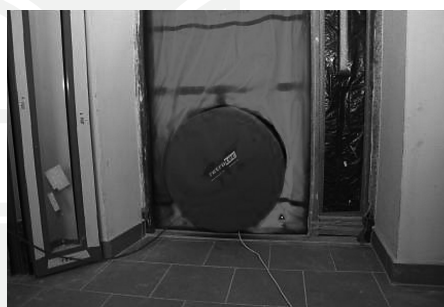
Tests were conducted using the Blowerdoor set (Fig. 2) with the digital controller Retrotec 3000 and Fantestic program to analyze test data.

Fig. 2b. Blowerdoor set –internal view

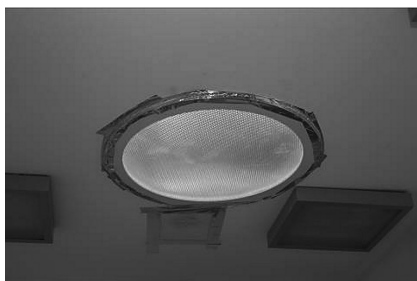
The buildings were prepared for the tests (method B), all openings in the building envelope such as windows, doors, ventilation ducts and openings next to the lightning devices were closed. Inside the building with the mechanical ventilation system, there is a lift shaft with a separate mechanical ventilation system. For the purpose of testing, the elevator shaft was cut off from the analyzed building volume. Figs. 3, 4 present the preparation of different building parts.

Fig. 3. Preparation of lighting fixtures

The problem of a too high  $n_{50}$  value in both buildings was mainly connected with the suspended ceilings in the buildings. Unfortunately, the roof construction above the ceiling was not tight – the air leakages were noticeable next to lighting fixtures mounted in the ceiling construction, however, direct monitoring of the roof construction was not possible.

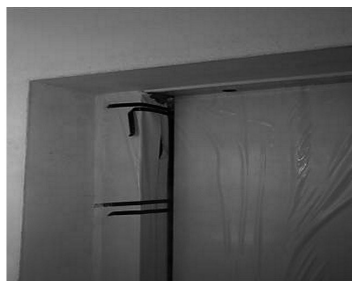
Fig. 4. Preparation of lift shaft

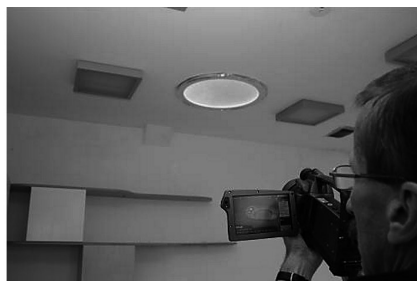
During the tests, all air leakages were monitored using a fog generator, an anemometer and an infrared camera. It allowed for the detection of both openings in the building envelope caused by inaccurate erection as well as the inaccurate building preparation (Figures 5 and 6). To make the monitoring possible and to increase the air flow through the openings, a pressure difference of up to 100 Pa was forced. It revealed the location of leaks but also loosened the sealed openings. This is the reason why the constant monitoring of all sealed openings should be done.

Fig. 6. Detection of leakages with infrared camera

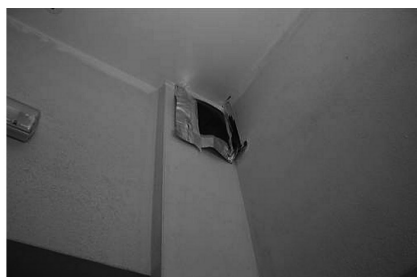
Fig. 8. Loosened sealed opening during the airtightness test
